Manhole Inspection Summary

Manhole # S39AA1006MH

Insp Date: **12/13/06 10:25 AM**

Location Address: **800 35TH ST**

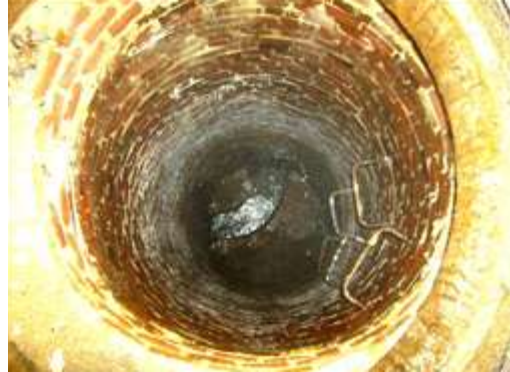
Top View

Corroded steps. Evidence of surcharge - Bench debris.

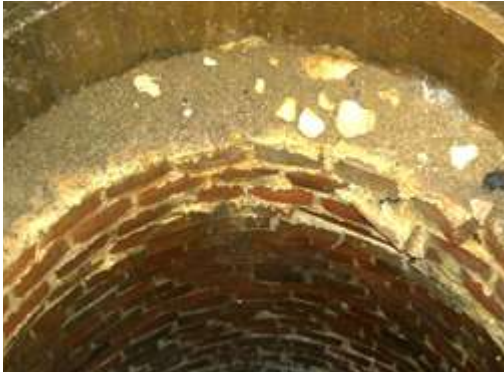
Defect

Frame Offset: **5** (in.) Condition: ☐ Sound ☐ Cracked ☒ **Leaks**

Condition: ☐ Sound ☐ Cracked ☐ Root Intrusion ☐ Loose Brick ☒ **Deteriorated**

Infiltration: ☐ None ☒ **Joint** ☐ Cracks ☐ Mortar ☐ Roots ☒ **Wall**

Frame leaks. Frame offset. Adjustment deterioration and infiltration.

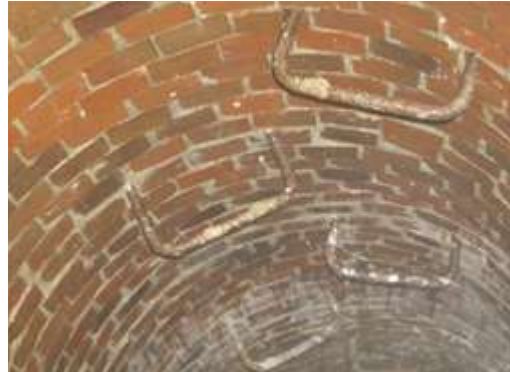
Defect

Infiltration: ☐ None ☐ Joint ☐ Cracks ☐ Mortar ☐ Roots ☒ **Wall**

Barrel infiltration.

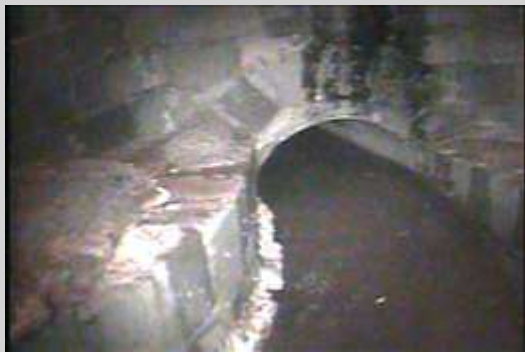
12 in. Circular Gravity Sewer Pipe Out @ 12 O'Clock

Deposits: ☐ None ☒ **Mud** ☐ Sludge ☐ **Debris** ☒ **Grease**

Silt Depth: **1** (in.) Deposits Extent: **Light**

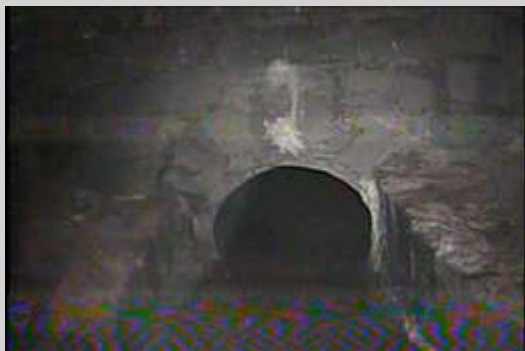
10 in. Circular Gravity Sewer Pipe In @ 9 O'Clock

Deposits: ☐ None ☒ **Mud** ☐ Sludge ☒ **Debris** ☐ Grease

Silt Depth: **0.5** (in.) Deposits Extent: **Light**
